Fixing a Sony Wega with a 6 or 7 blink code

I converted the web article into this set of printable instructions as a way to make this repair easier for those who want to have a printed reference so that it won't be necessary to keep referring to a computer while doing the repair. The original article can be found here: <http://k0lee.com/2011/05/fixing-a-sony-wega-with-6-or-7-blink-code/>

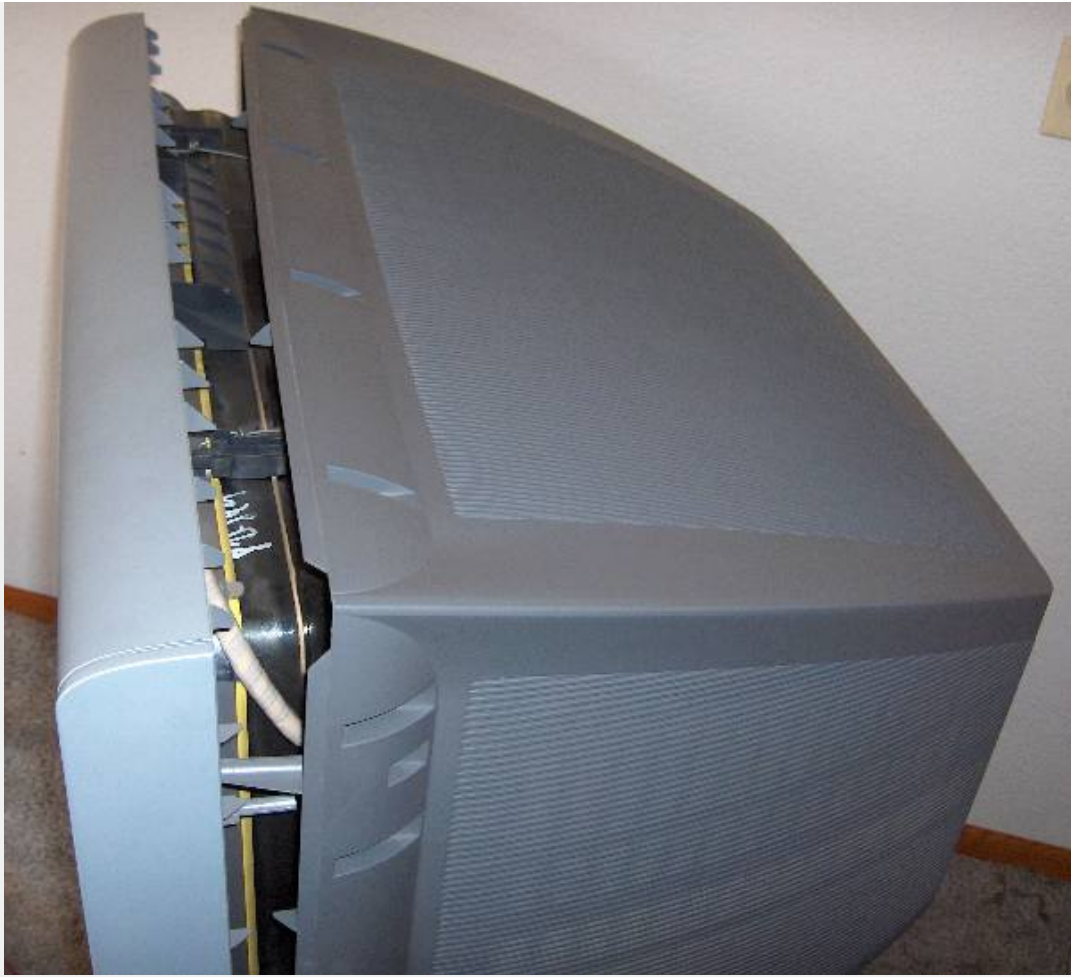
Fig 1. After removing about a 17 screws, the rear shell can be slipped off.

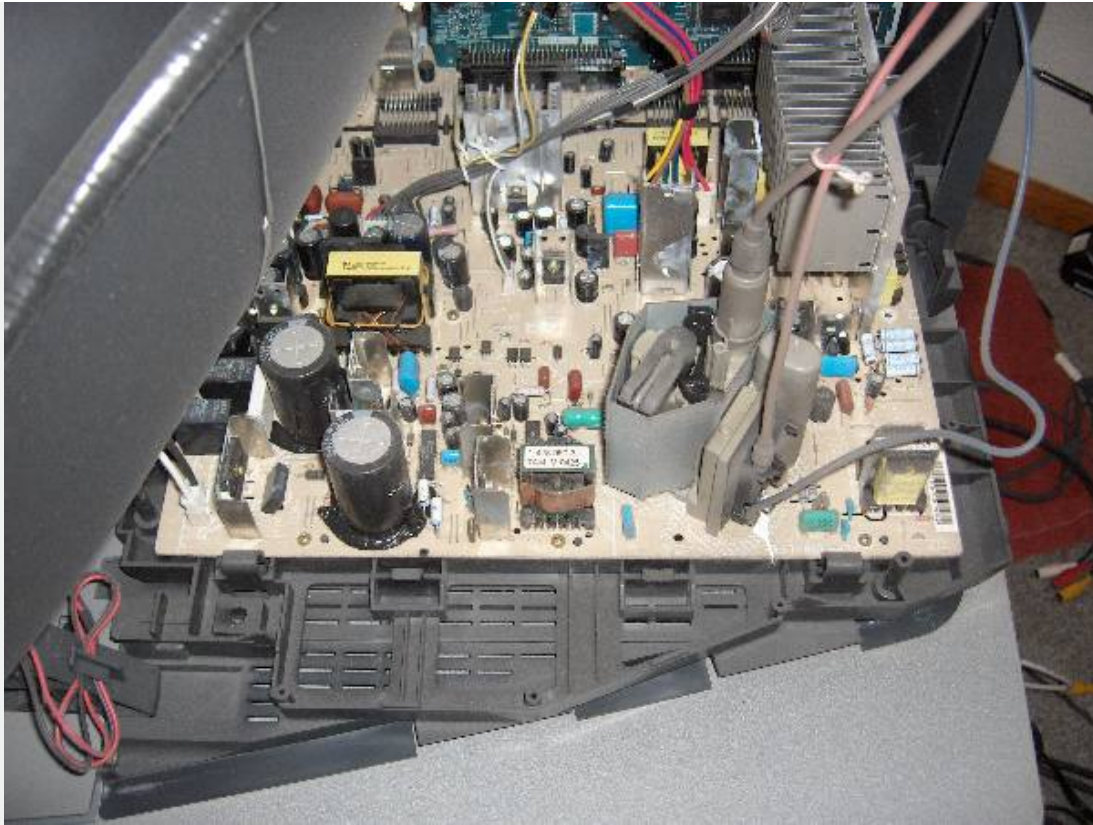
Fig 3. The 'D' board shown above is held in with about 8 screws.

It wasn't clear how to remove the board, or if it would be necessary to undo all of the wiring connections. Some of the connectors were easy to remove, but the 3 high voltage wires that connect to the CRT did not have easy-to-unplug connections. I eventually figured out that I didn't need to remove those wires at all. There are a number of connectors that need to be flipped upward to disconnect the 'D' board from an adjacent board. It wasn't clear at first how they worked, but if you pull them upward, they unsnap from the 'D' board and pivot up 90 degrees like a draw bridge. I unplugged all the other cables I could find, removed about 8 screws, and the board came out far enough to let me rotate it into a position where I could access the bottom of the board. It was necessary to use a stubby screw driver to remove one screw that was far forward, hidden between two connectors, and just under the CRT. The board was still tethered by the high voltage connections, but I was able to fix it 'in place', by turning it over like shown in the image below.

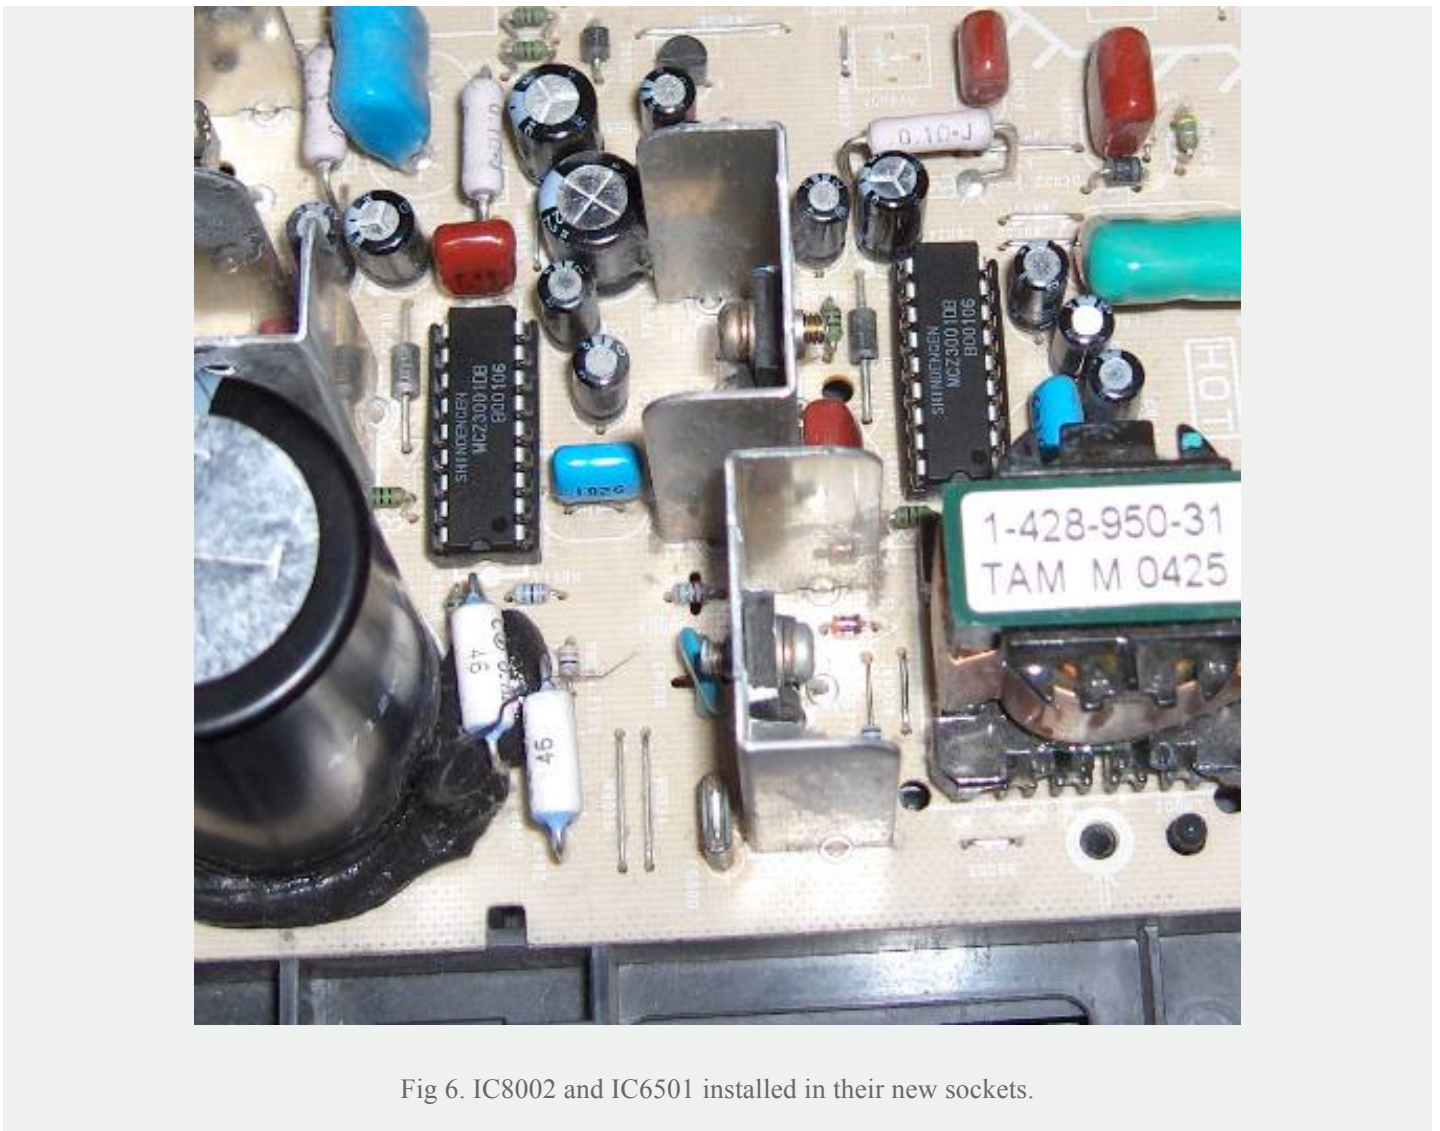
Fig 6. IC8002 and IC6501 installed in their new sockets.

Be aware that each chip has two pins are not soldered to the board (pins 13 and 17) on most D-boards. This is normal and so don't solder those pins if they weren't soldered initially or else the fix will not work. Take note of the orientation of the chips since there is a notch on one end facing the closest edge of the board. You do NOT want to install the chips backwards. Also, don't solder the new chips in directly. Use sockets in case you ever need to do this repair again, since having to unsolder these chips is what creates most of the work. If they were socketed in the first place, you could replace them without having to remove the board or doing any soldering at all.

After replacing the ICs with sockets, you'll need to install the replacement ICs. Odds are that only one of the chips is bad, but since you won't know which one, it's best to just replace them both. It is necessary to squeeze the pins together to get the legs aligned with the holes in the sockets. This style of IC has its legs spread out by default, and so they won't automatically align unless you pre-bend them inward just a little to align with the holes in the socket. Carefully examine the chips after you install them to make sure all the legs made it into the socket.
